# Electrical Condition Monitoring with Ultrasound

## Powerhouse MCC Room Ultrasound Report

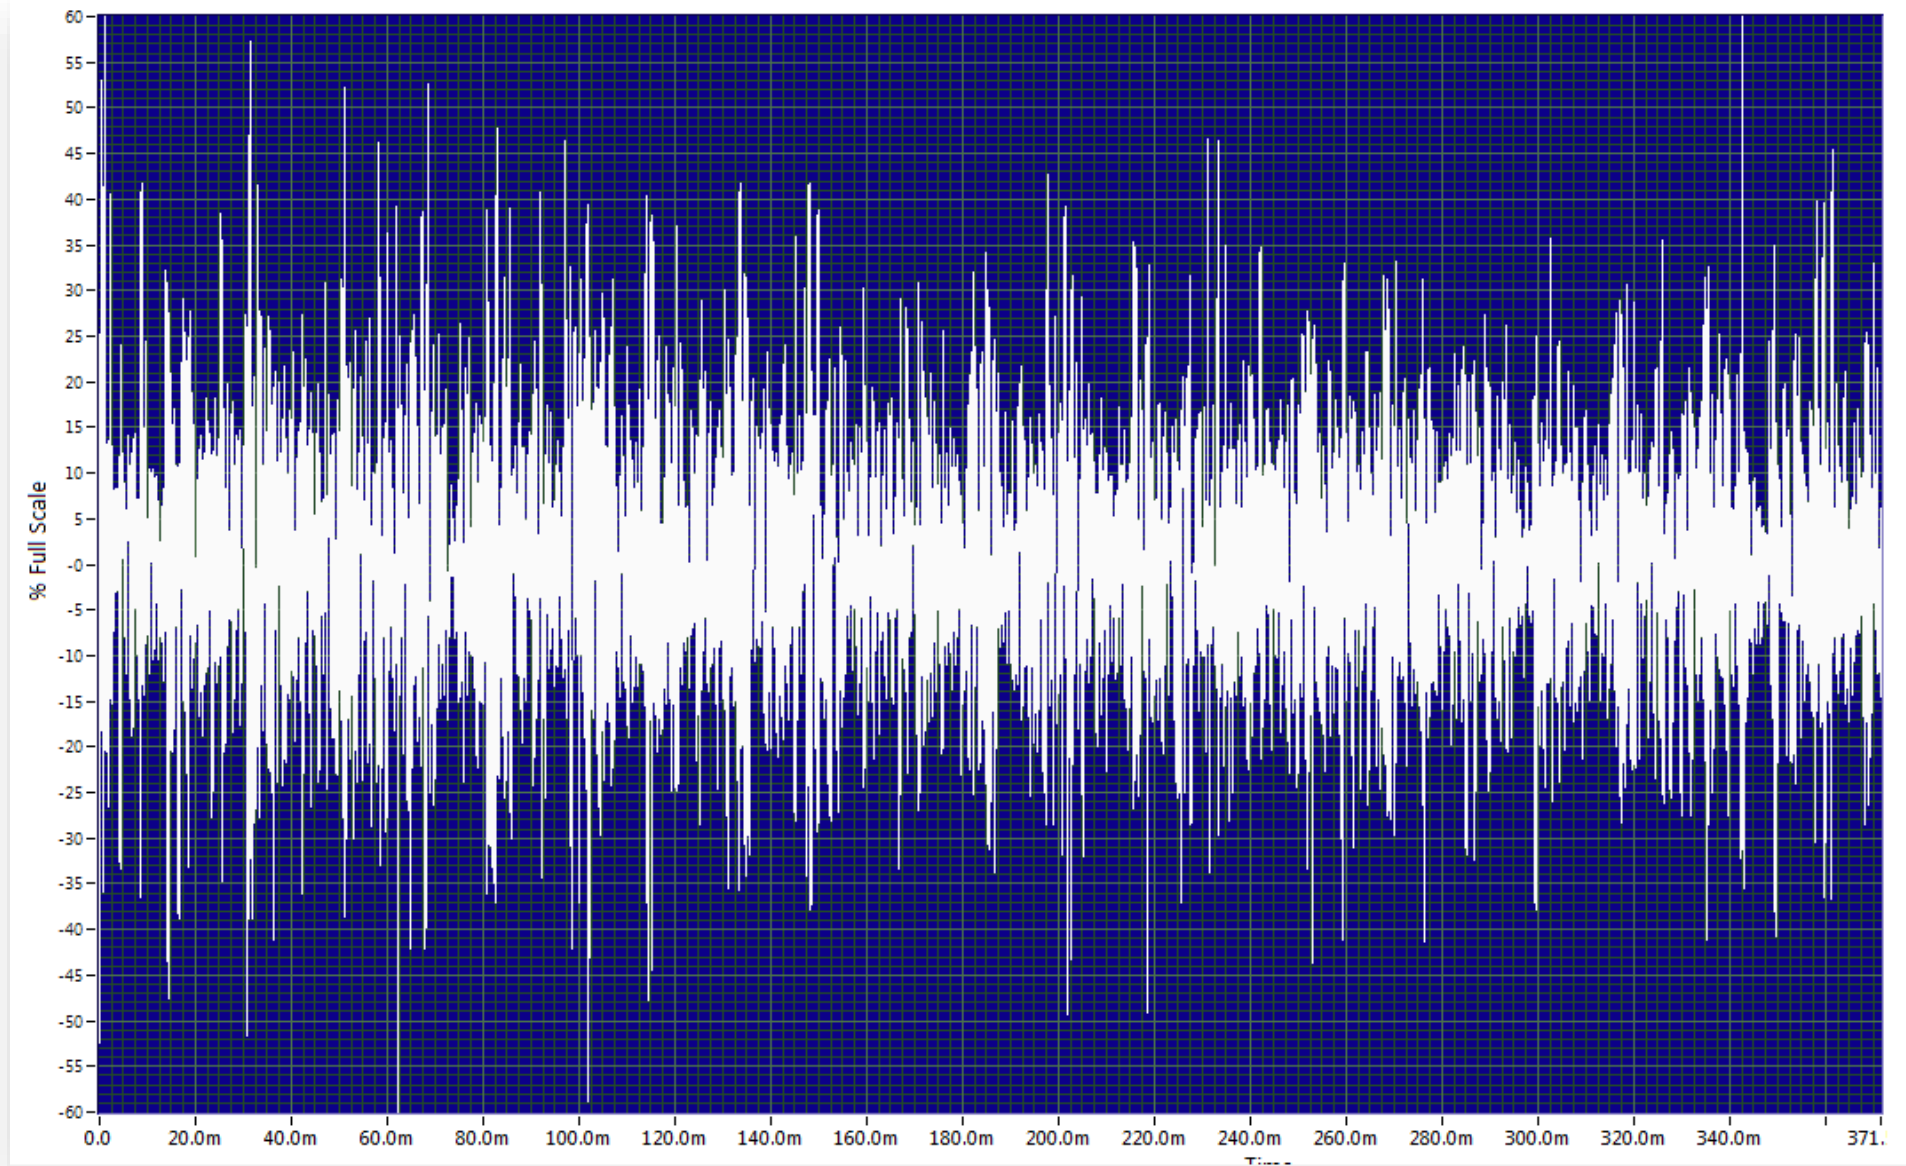
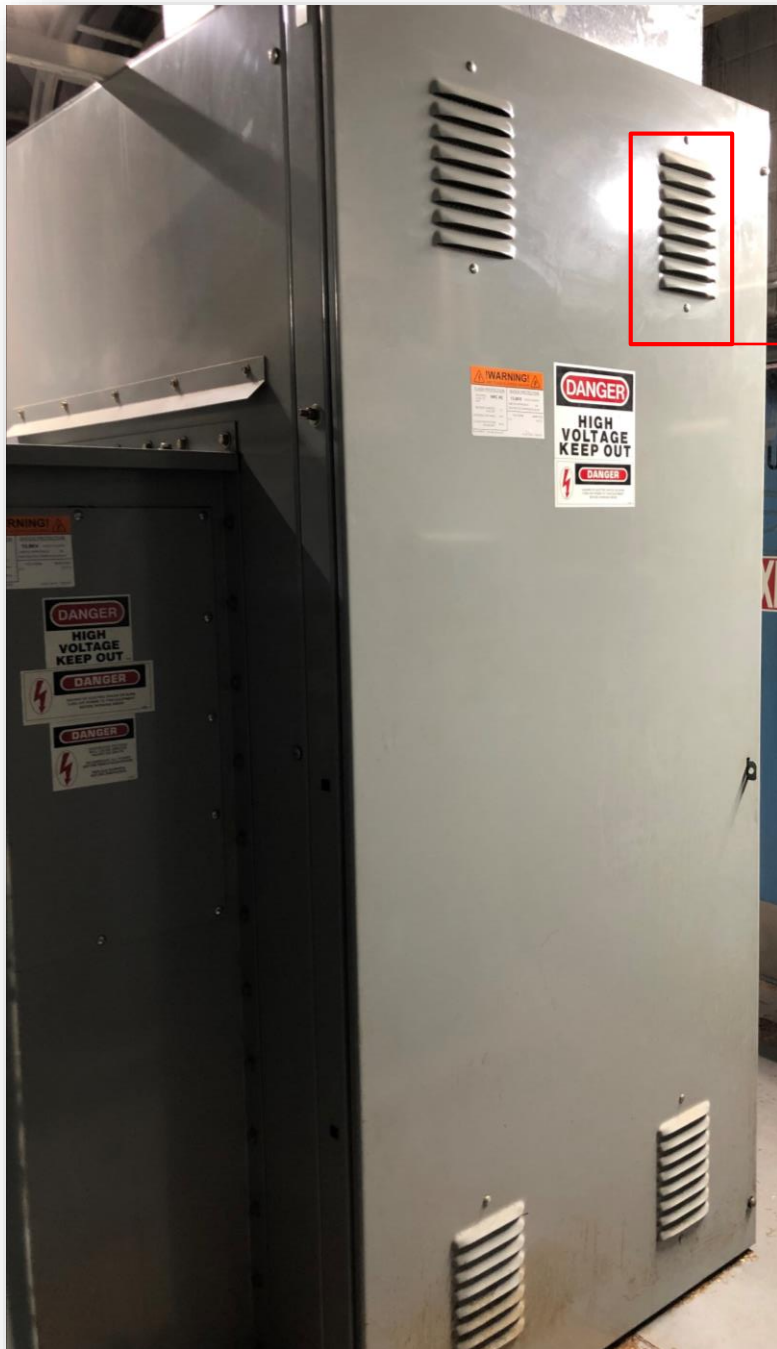
# Primary Switch

Location of recording.

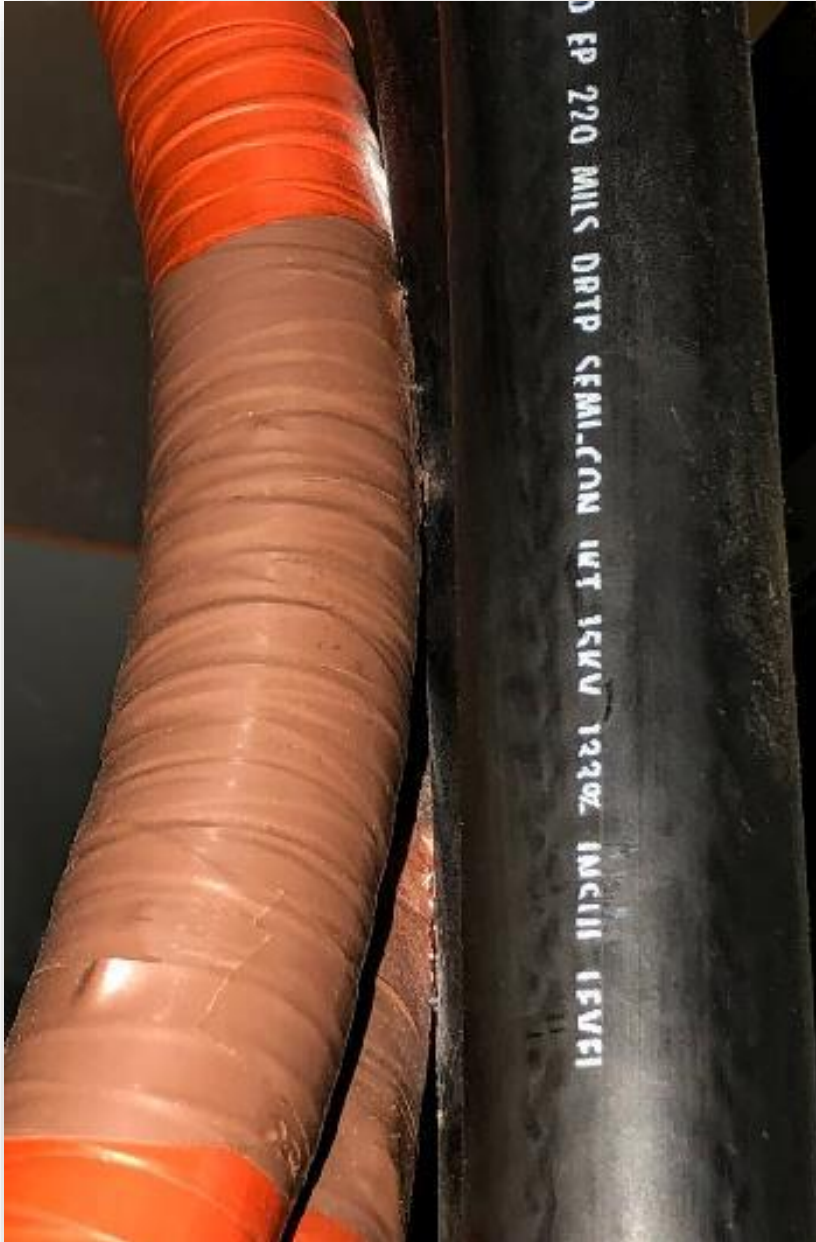
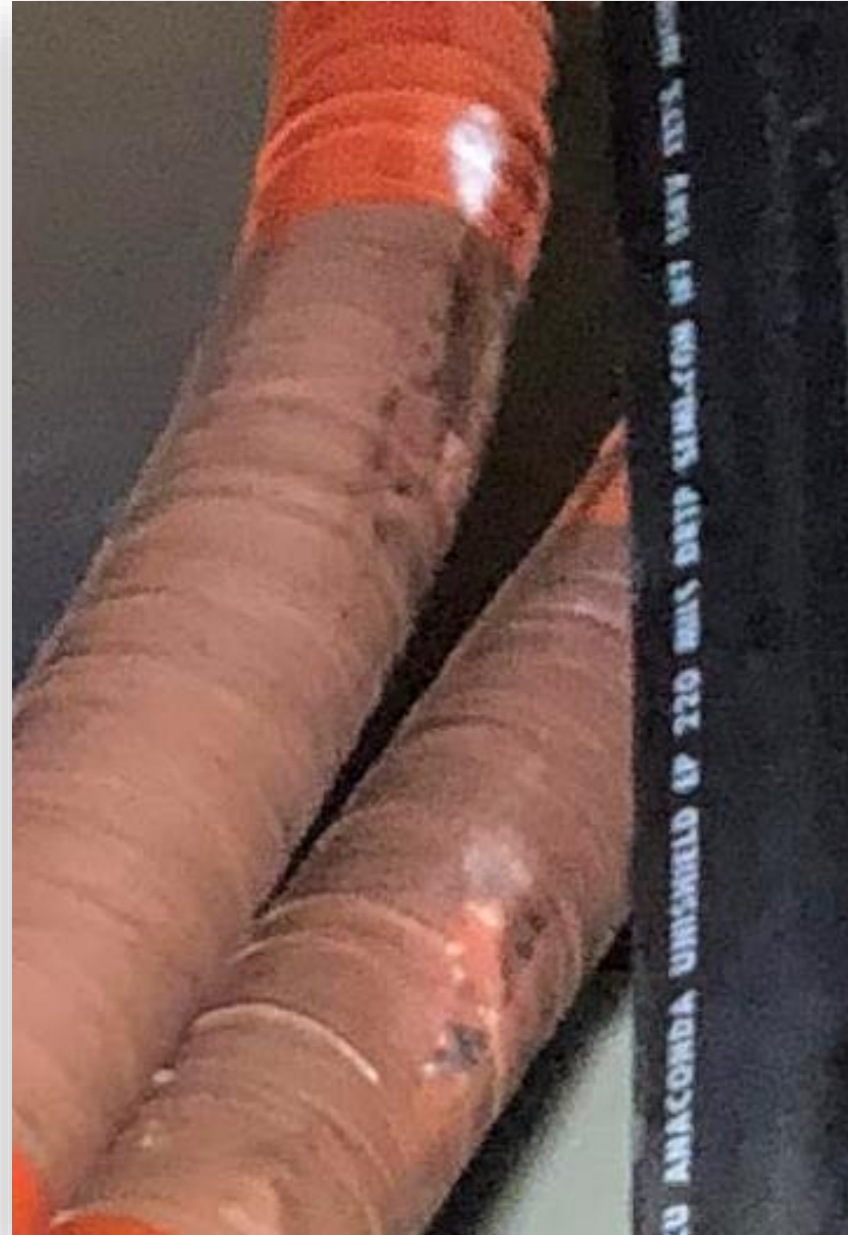
## Primary Switch - Tracking

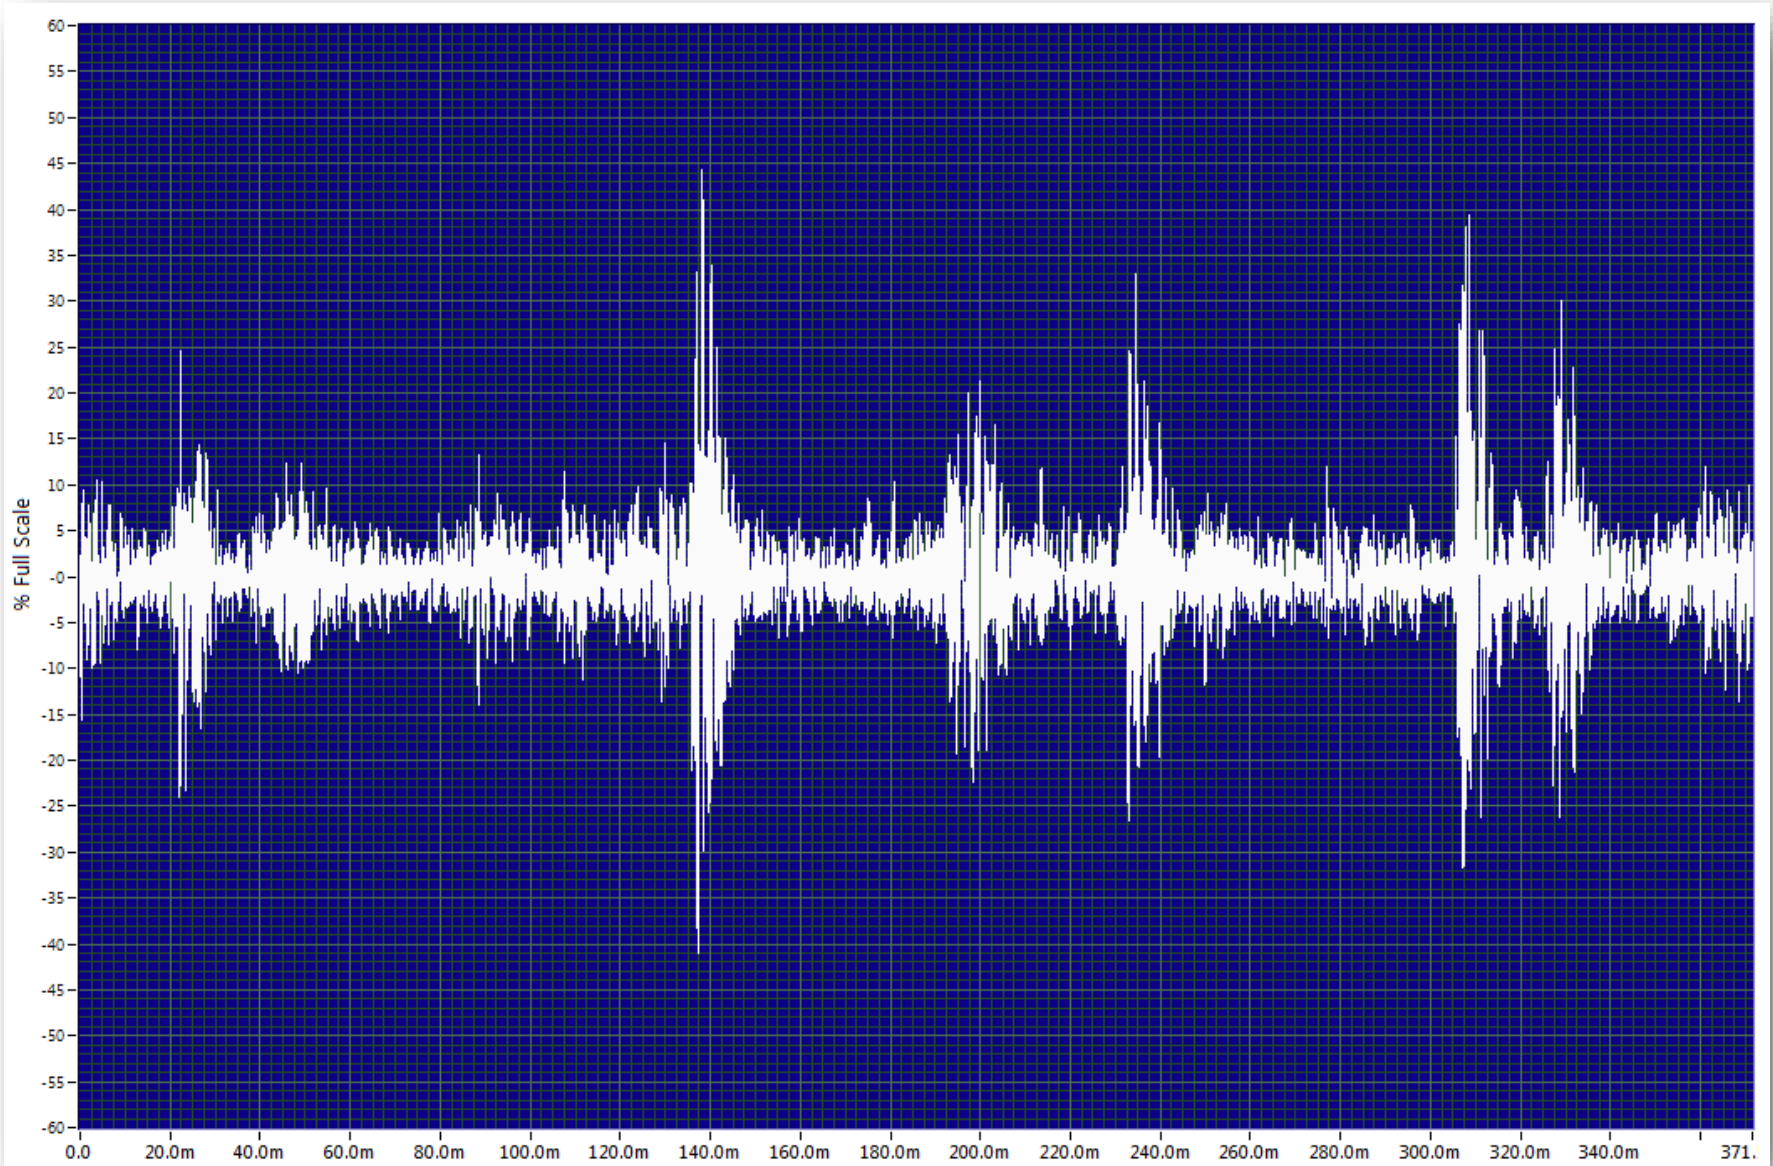
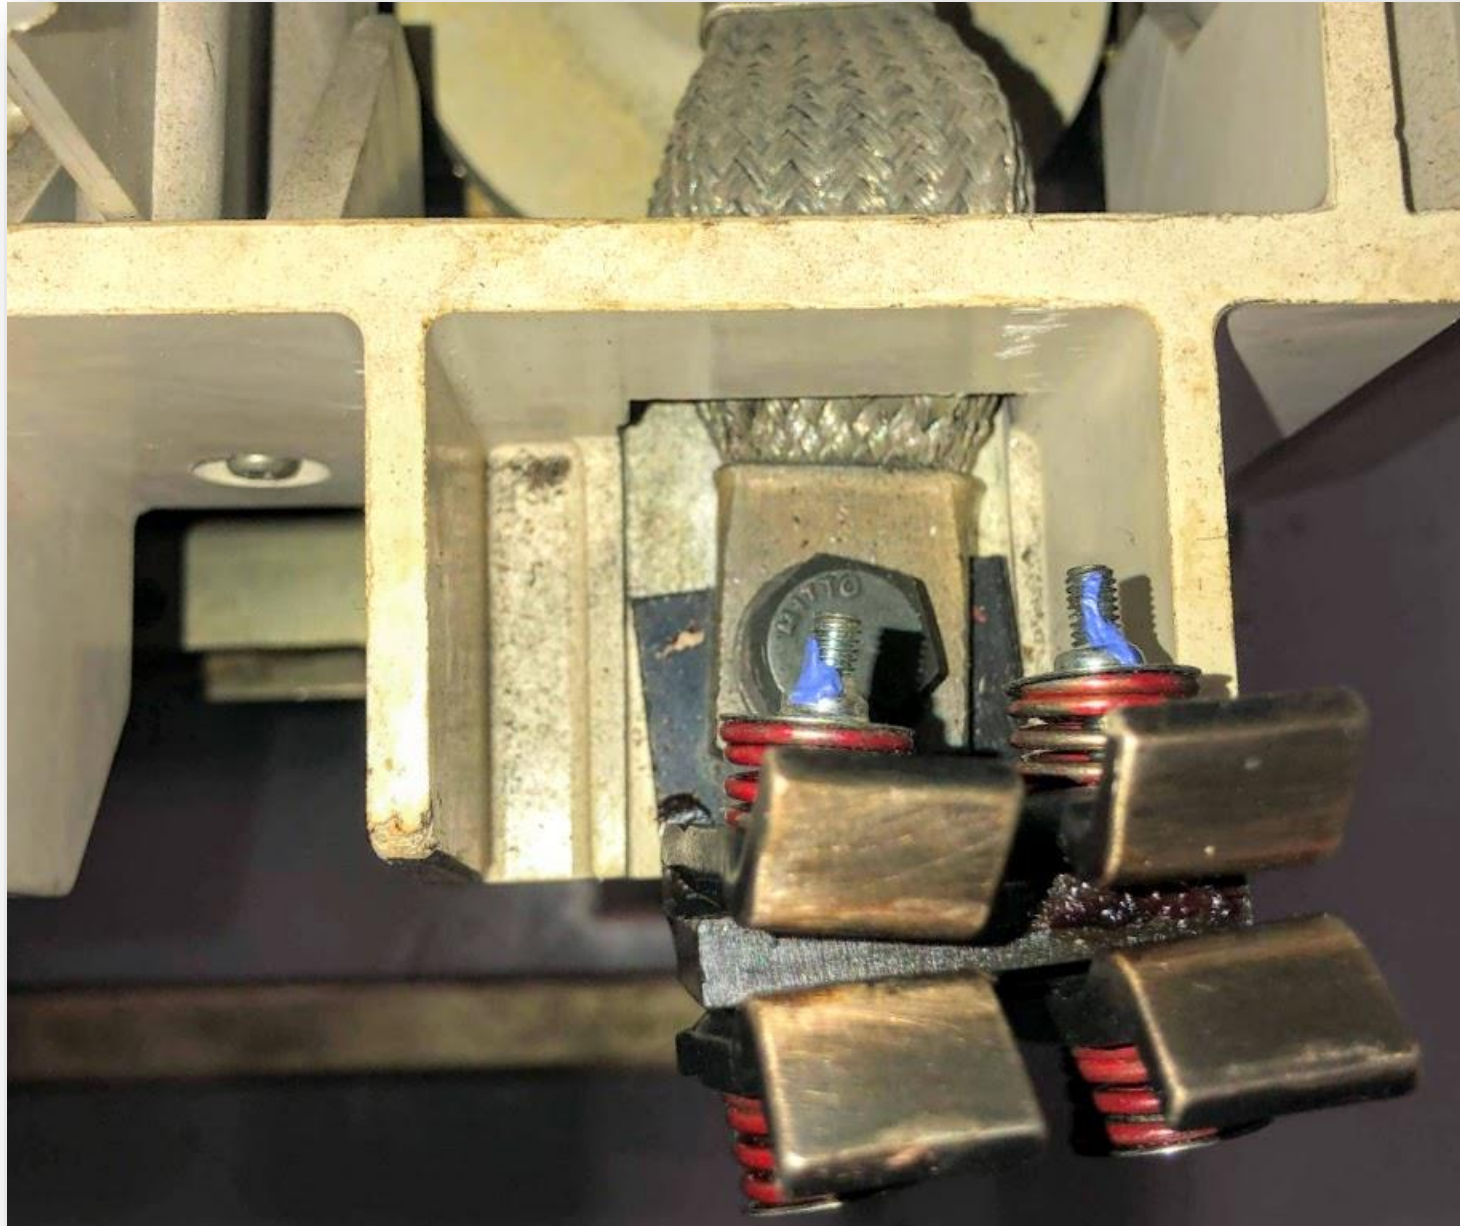
# 4160V Starter

## 4160V Starter - Arcing

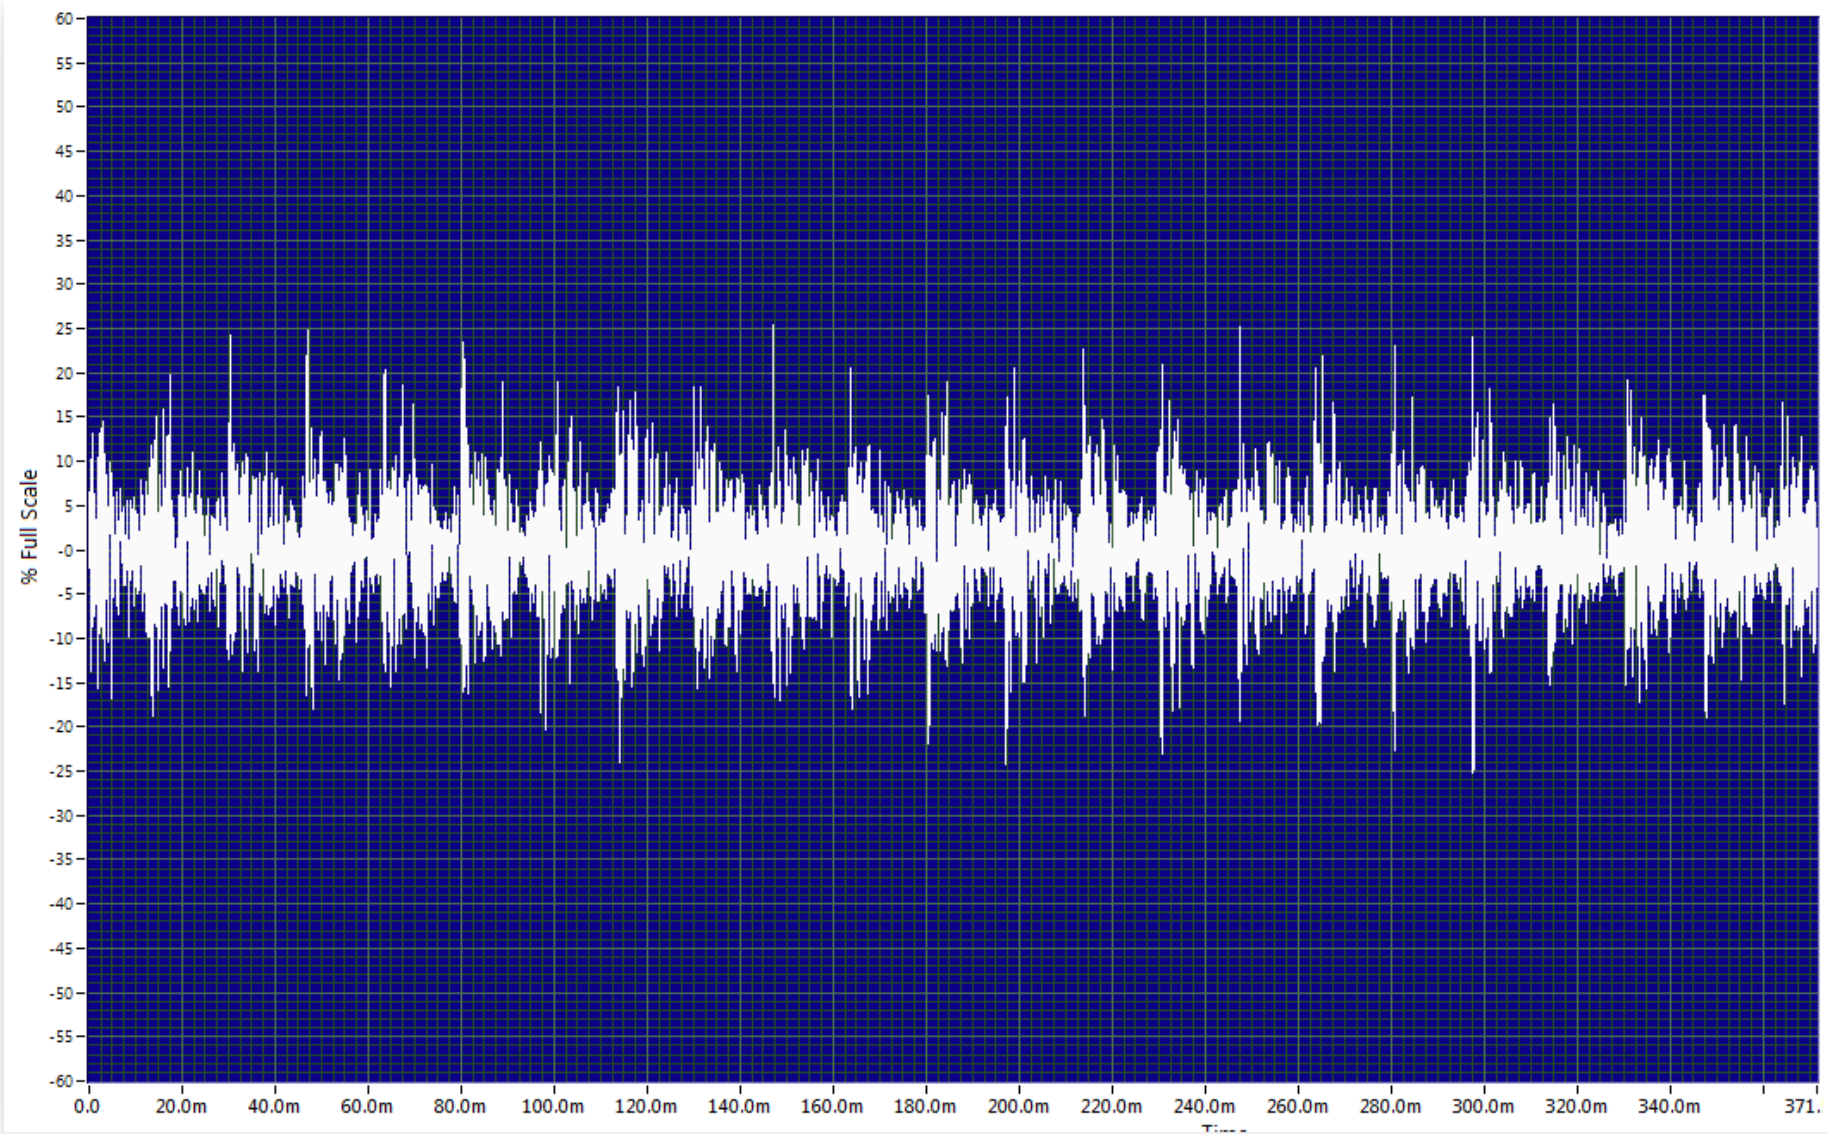
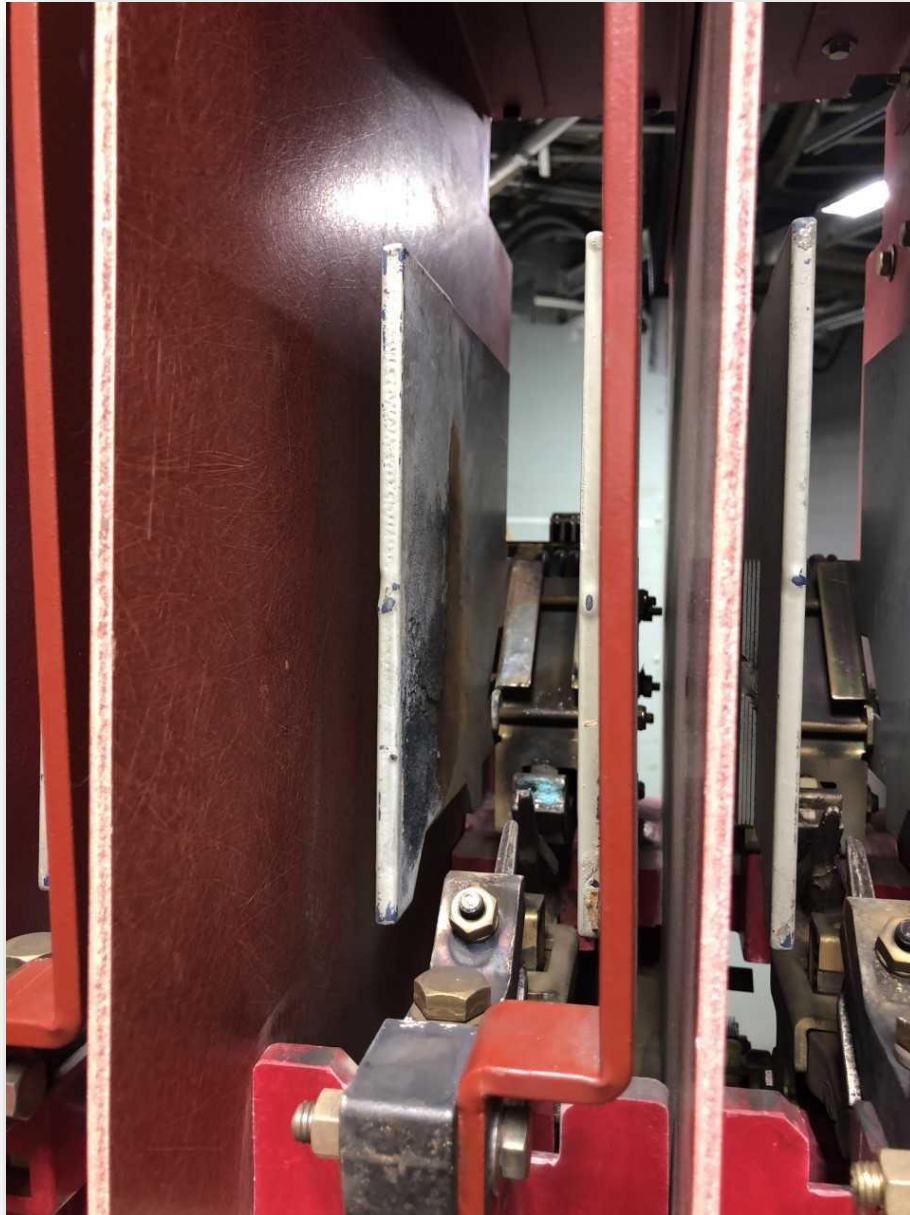
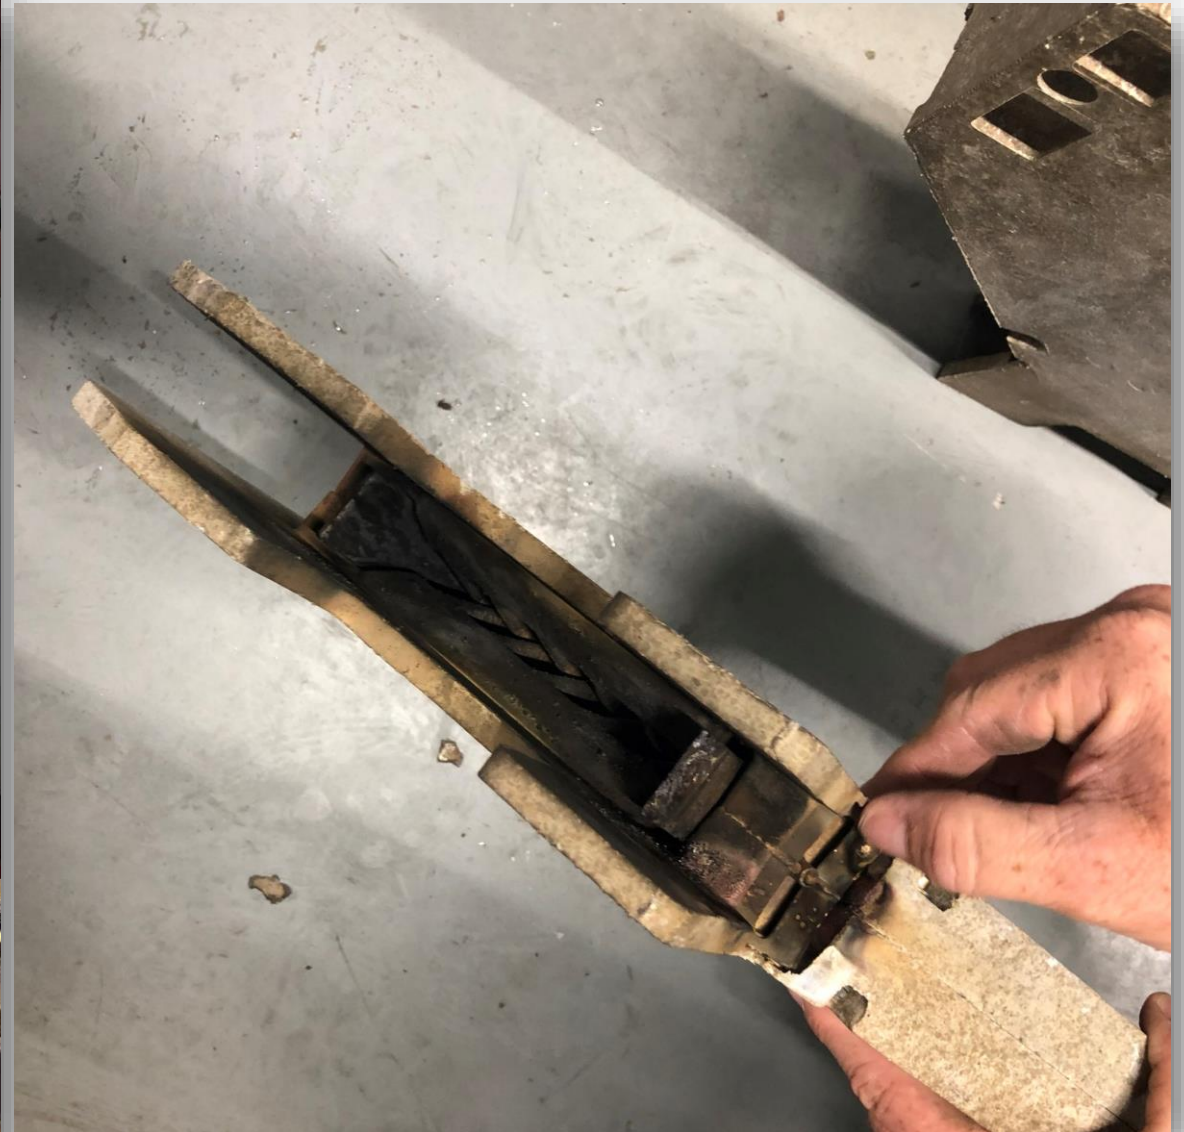
# 4160V Starter

## 4160V Starter – Corona

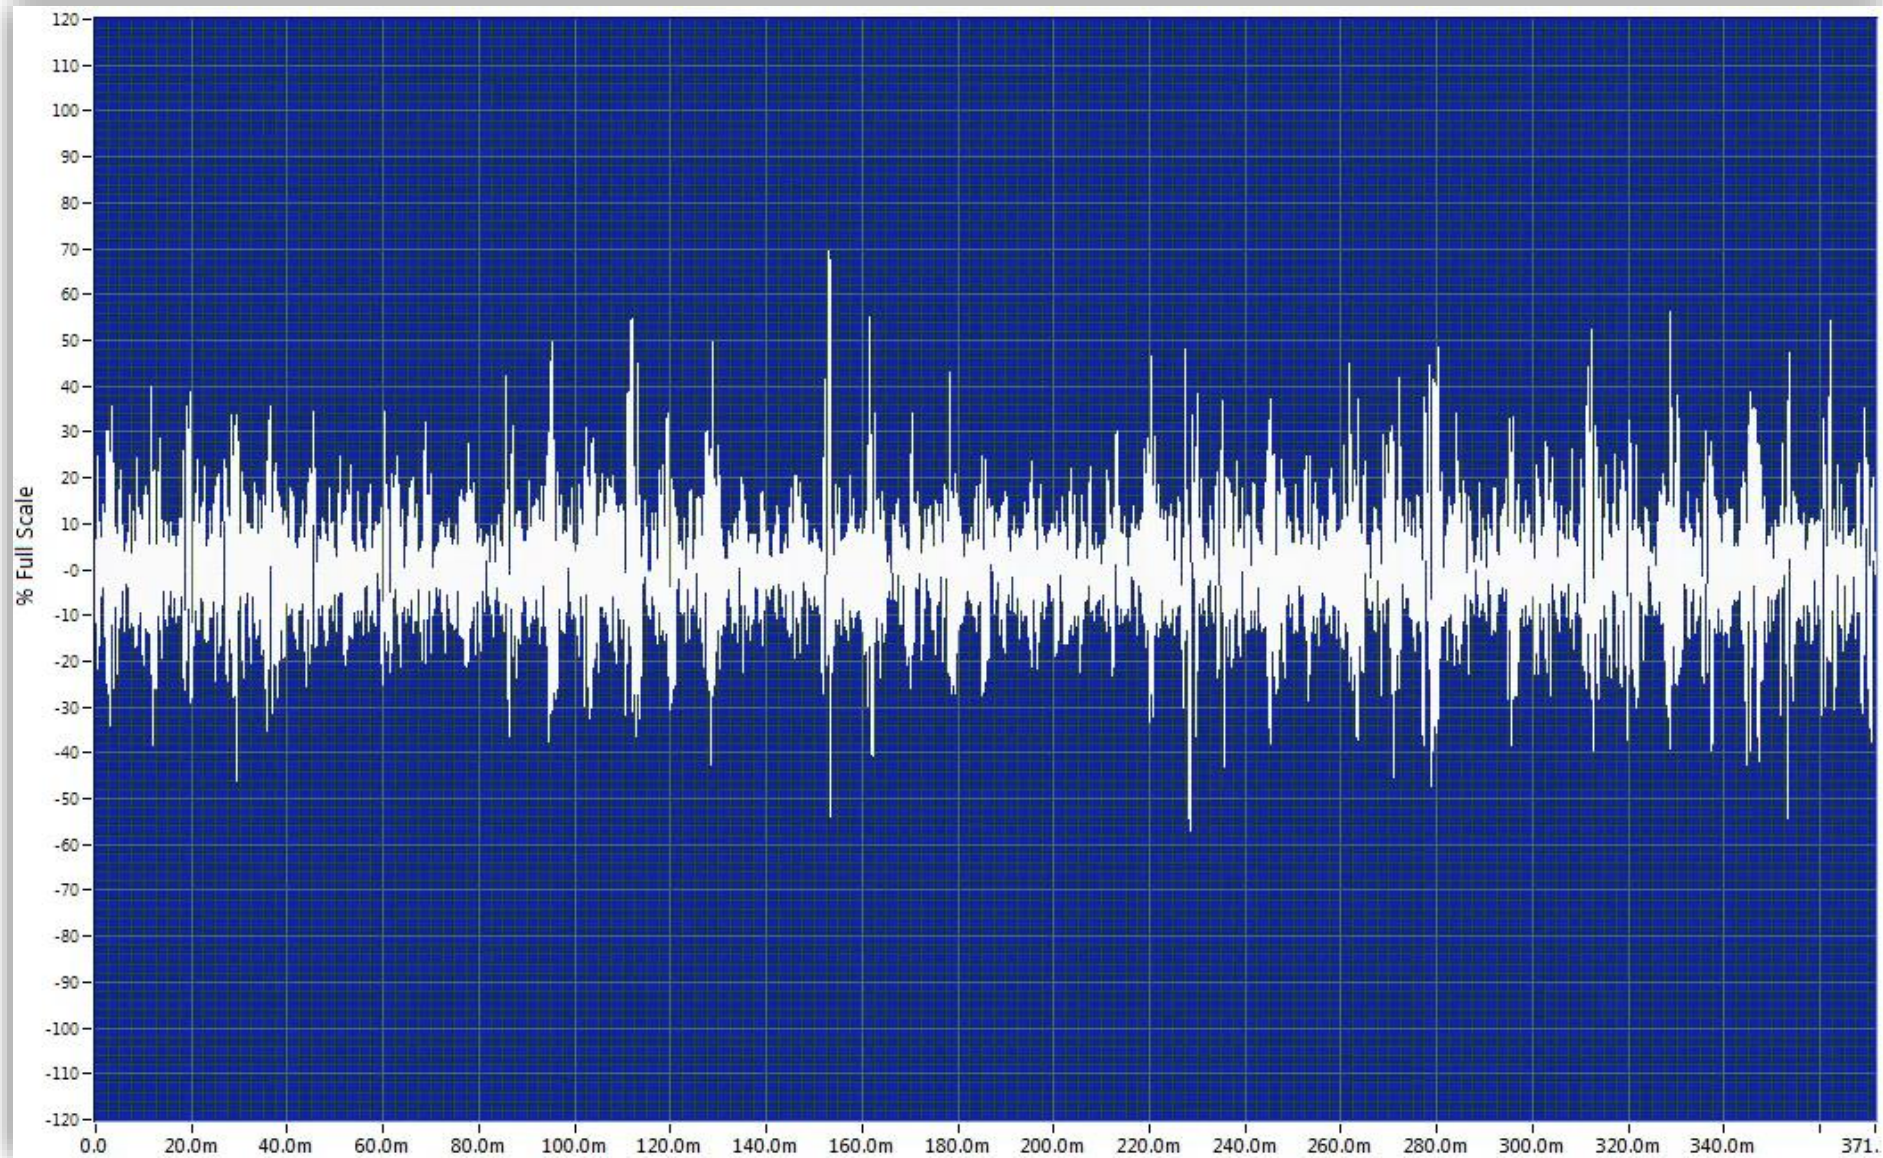
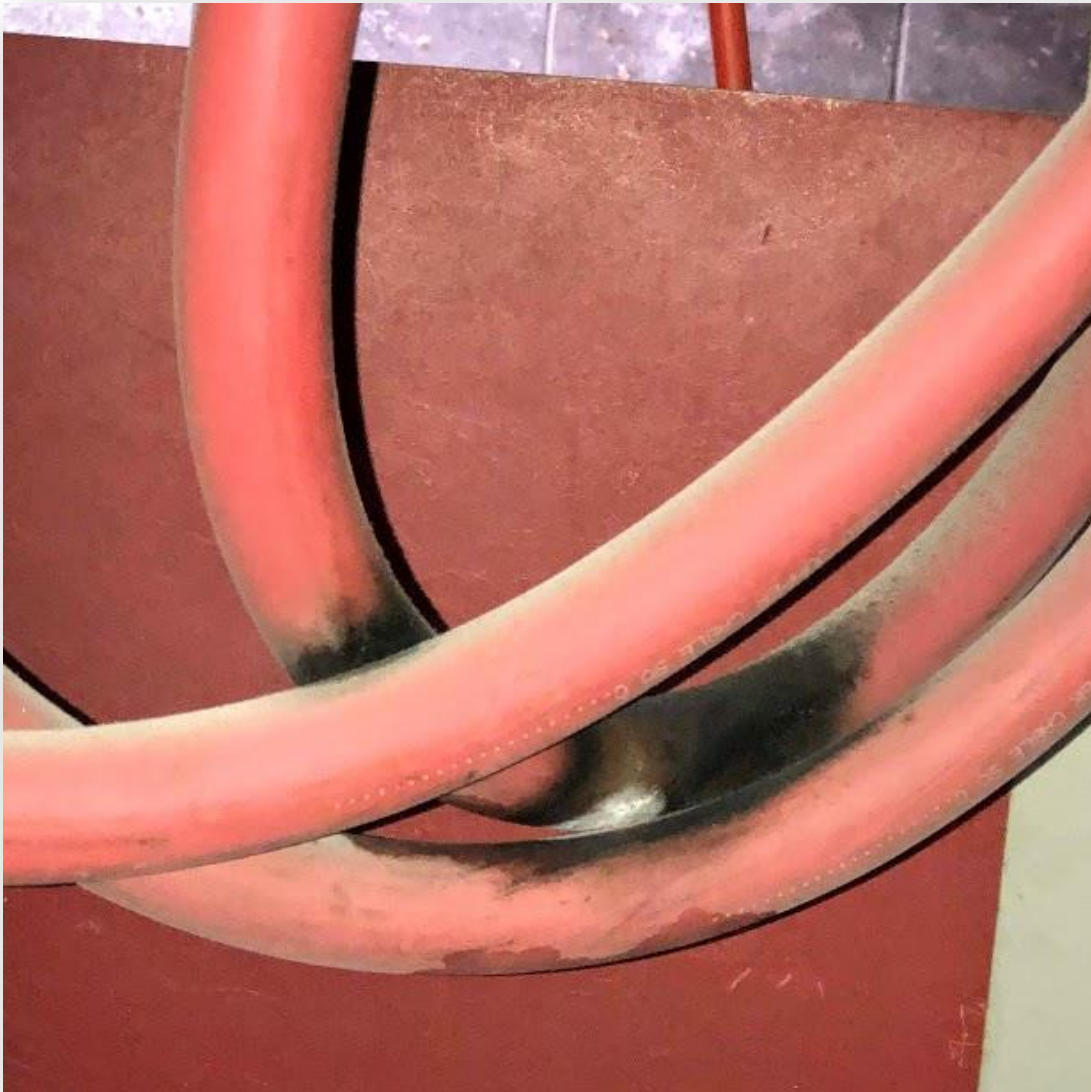
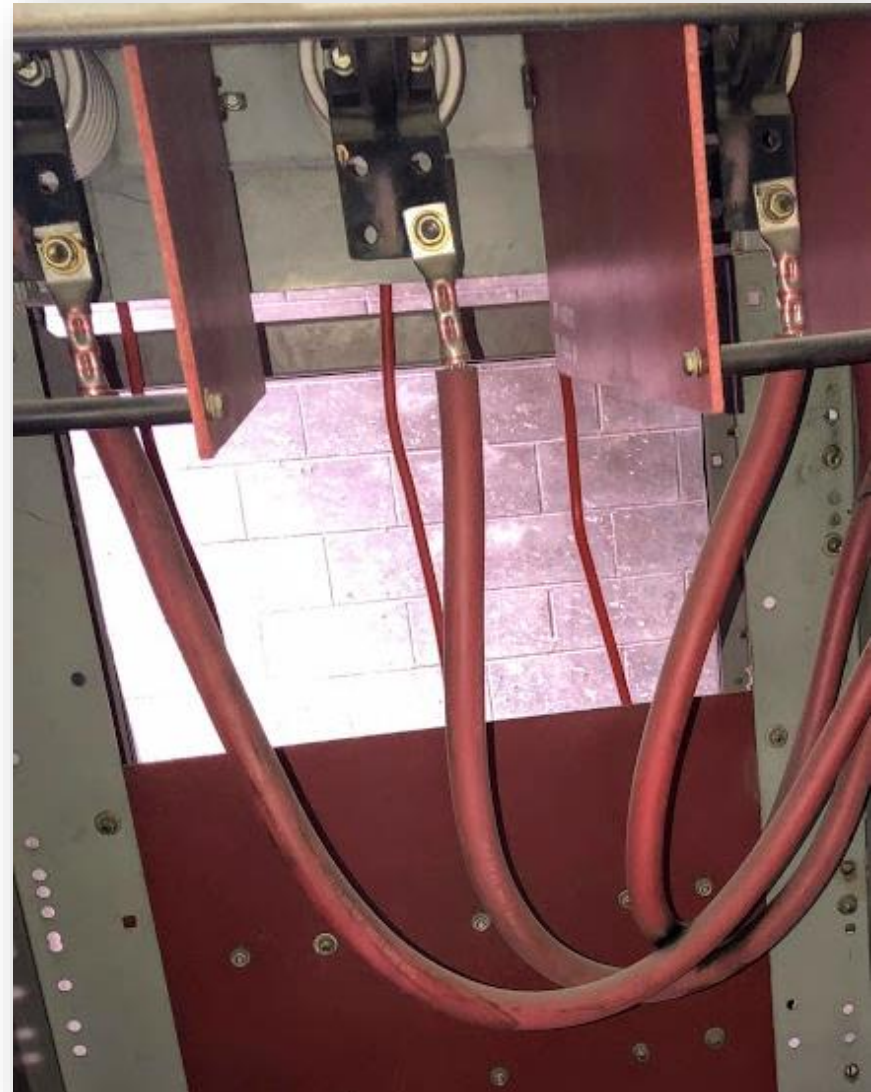
# Primary Switch

## Primary Switch - Tracking

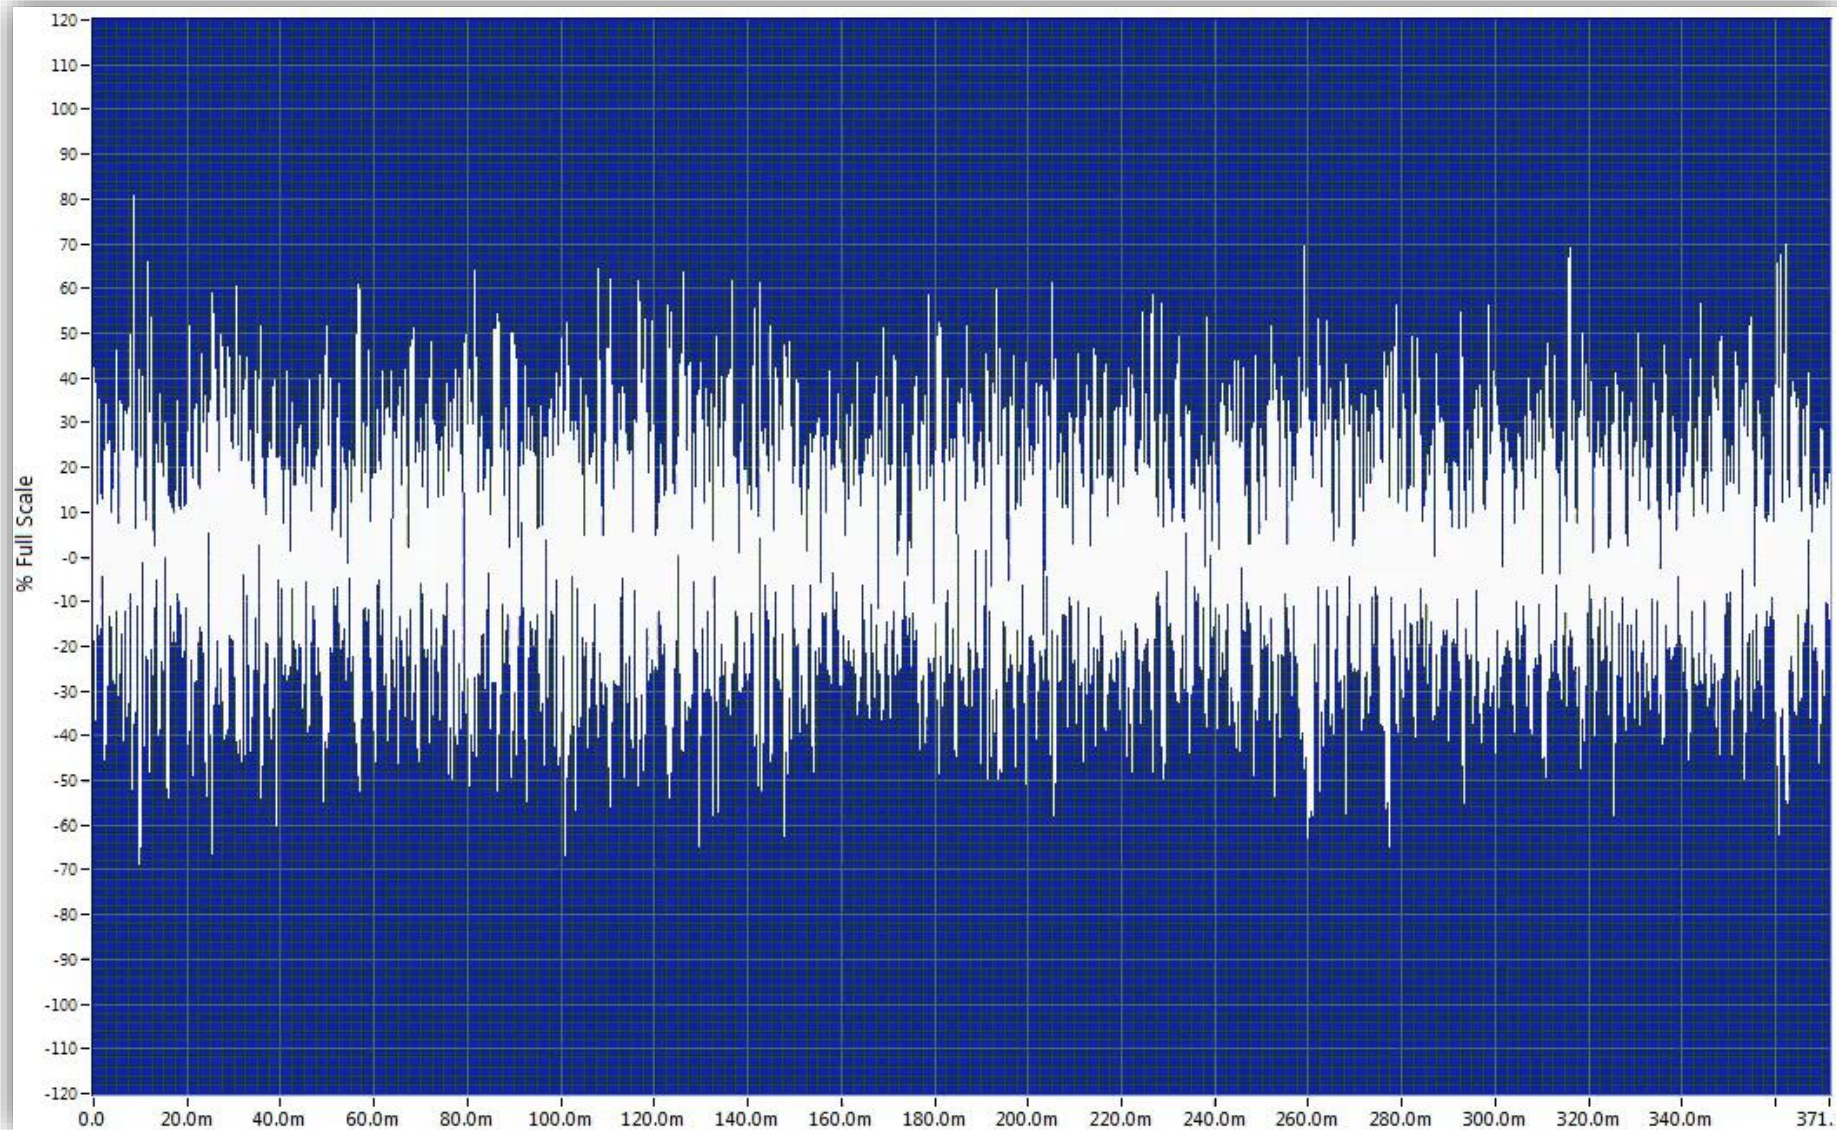
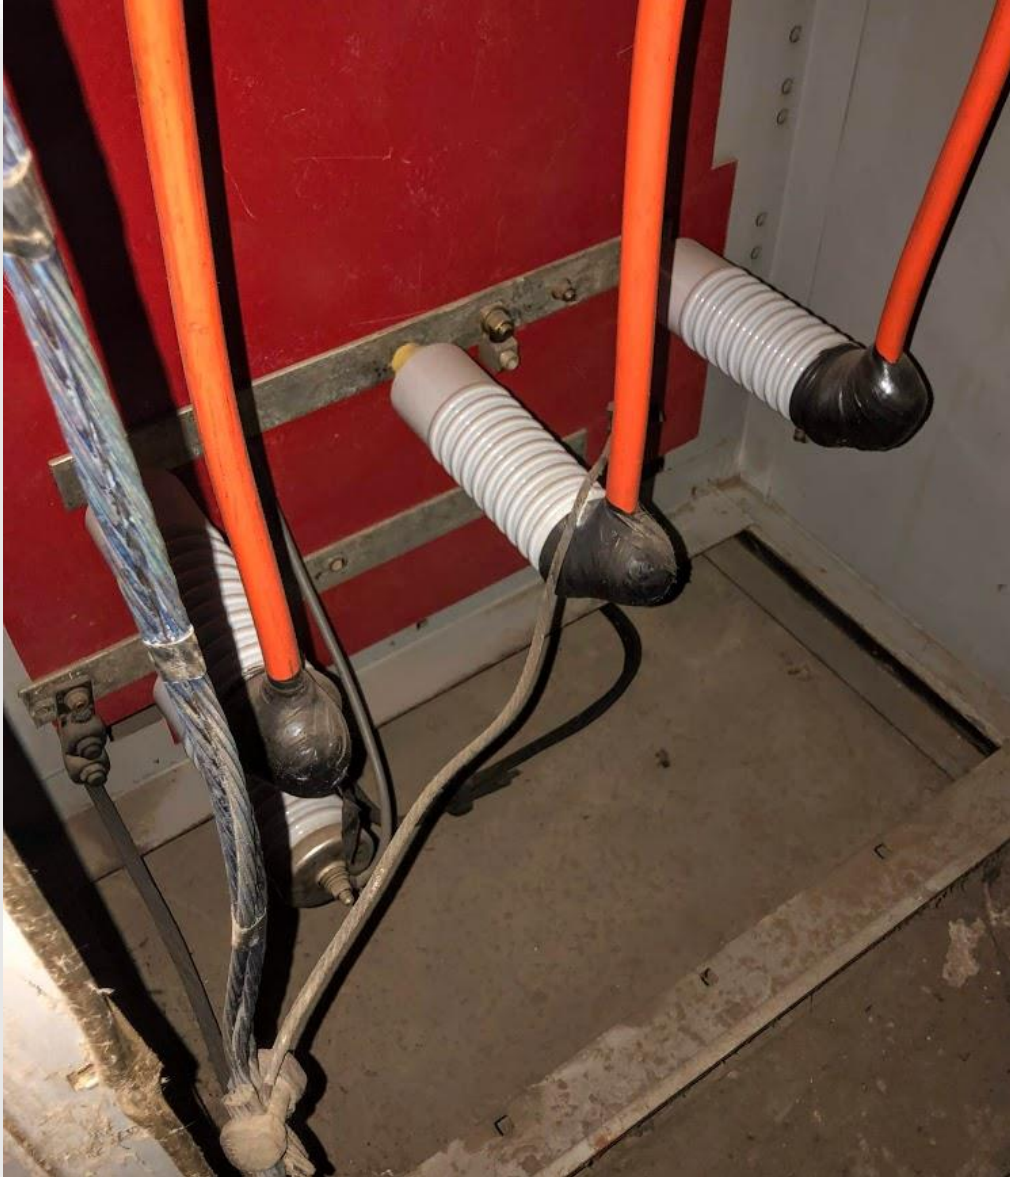
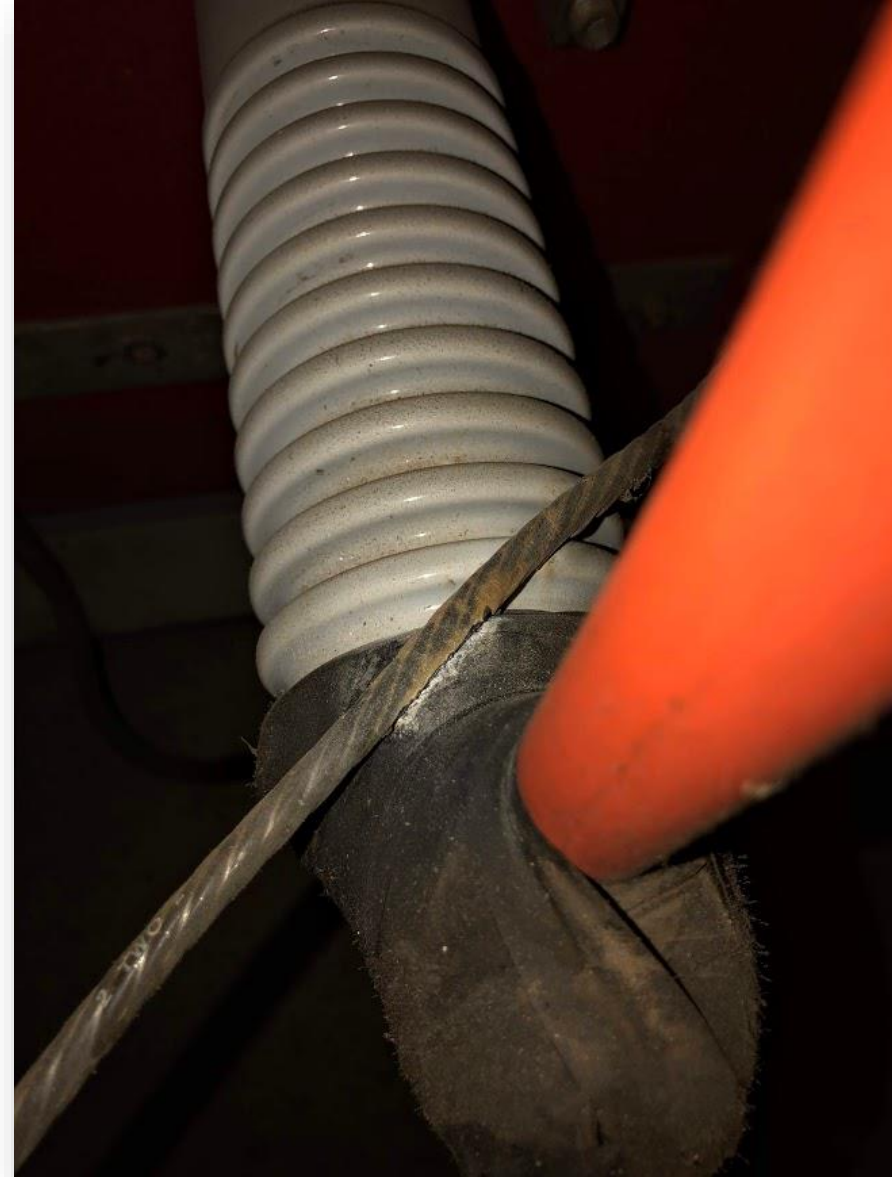
# Primary Switch

## Primary Switch - Tracking
