# Electrical Condition Monitoring with Ultrasound

## Powerhouse MCC Room Ultrasound Report

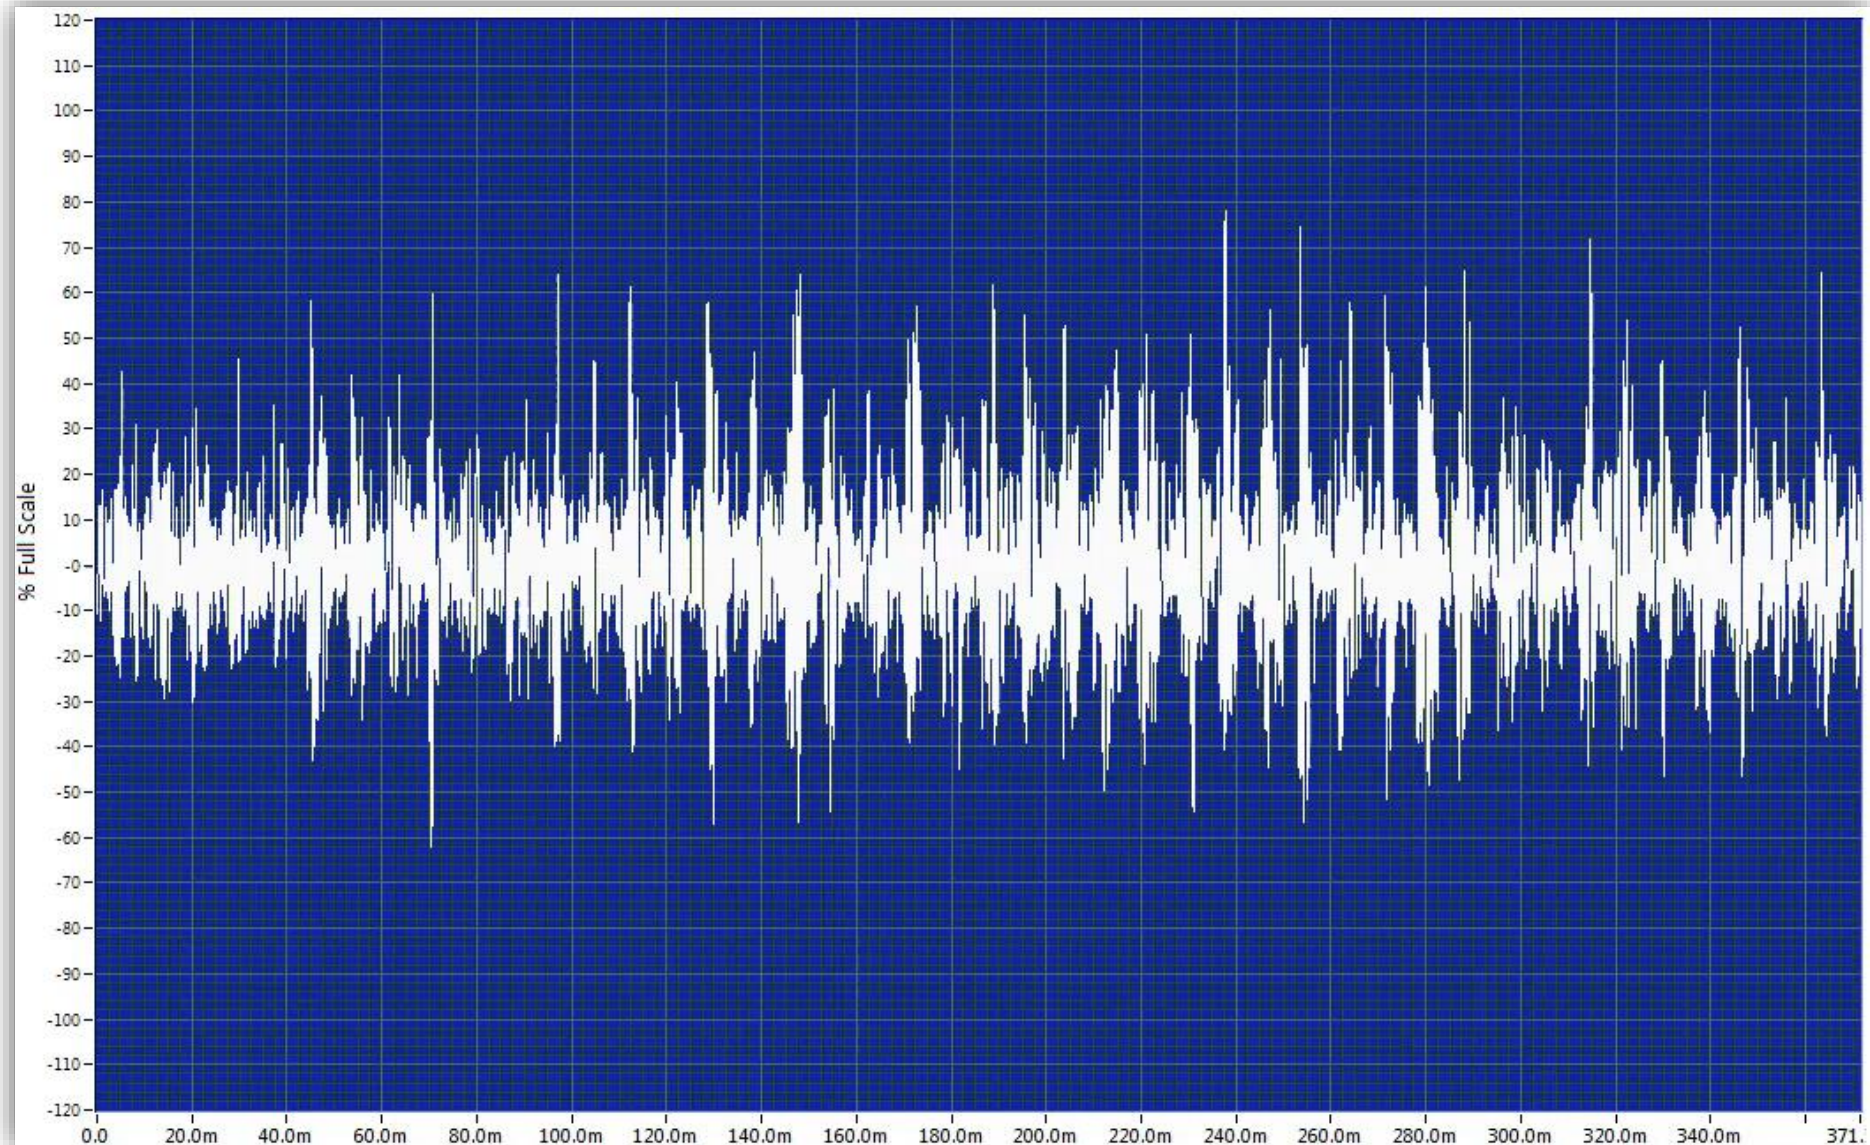
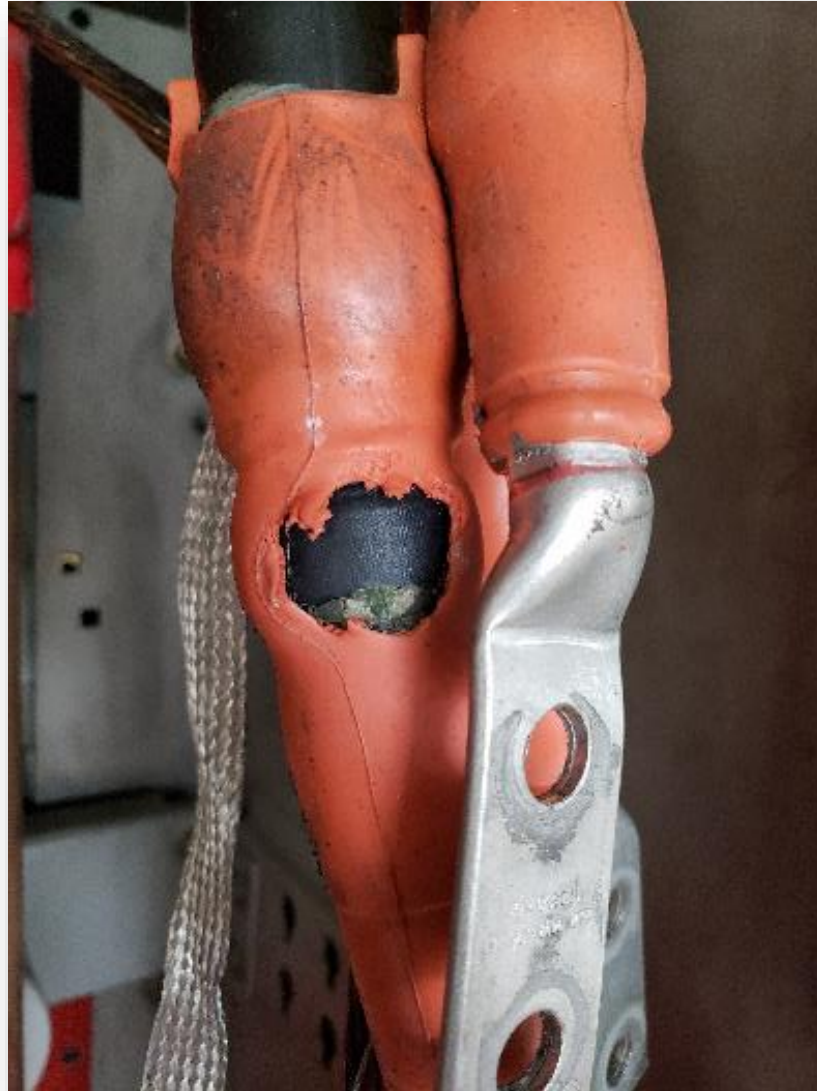
# Primary Switch - Tracking Rubbing due to Cable Contact and Overcrowding

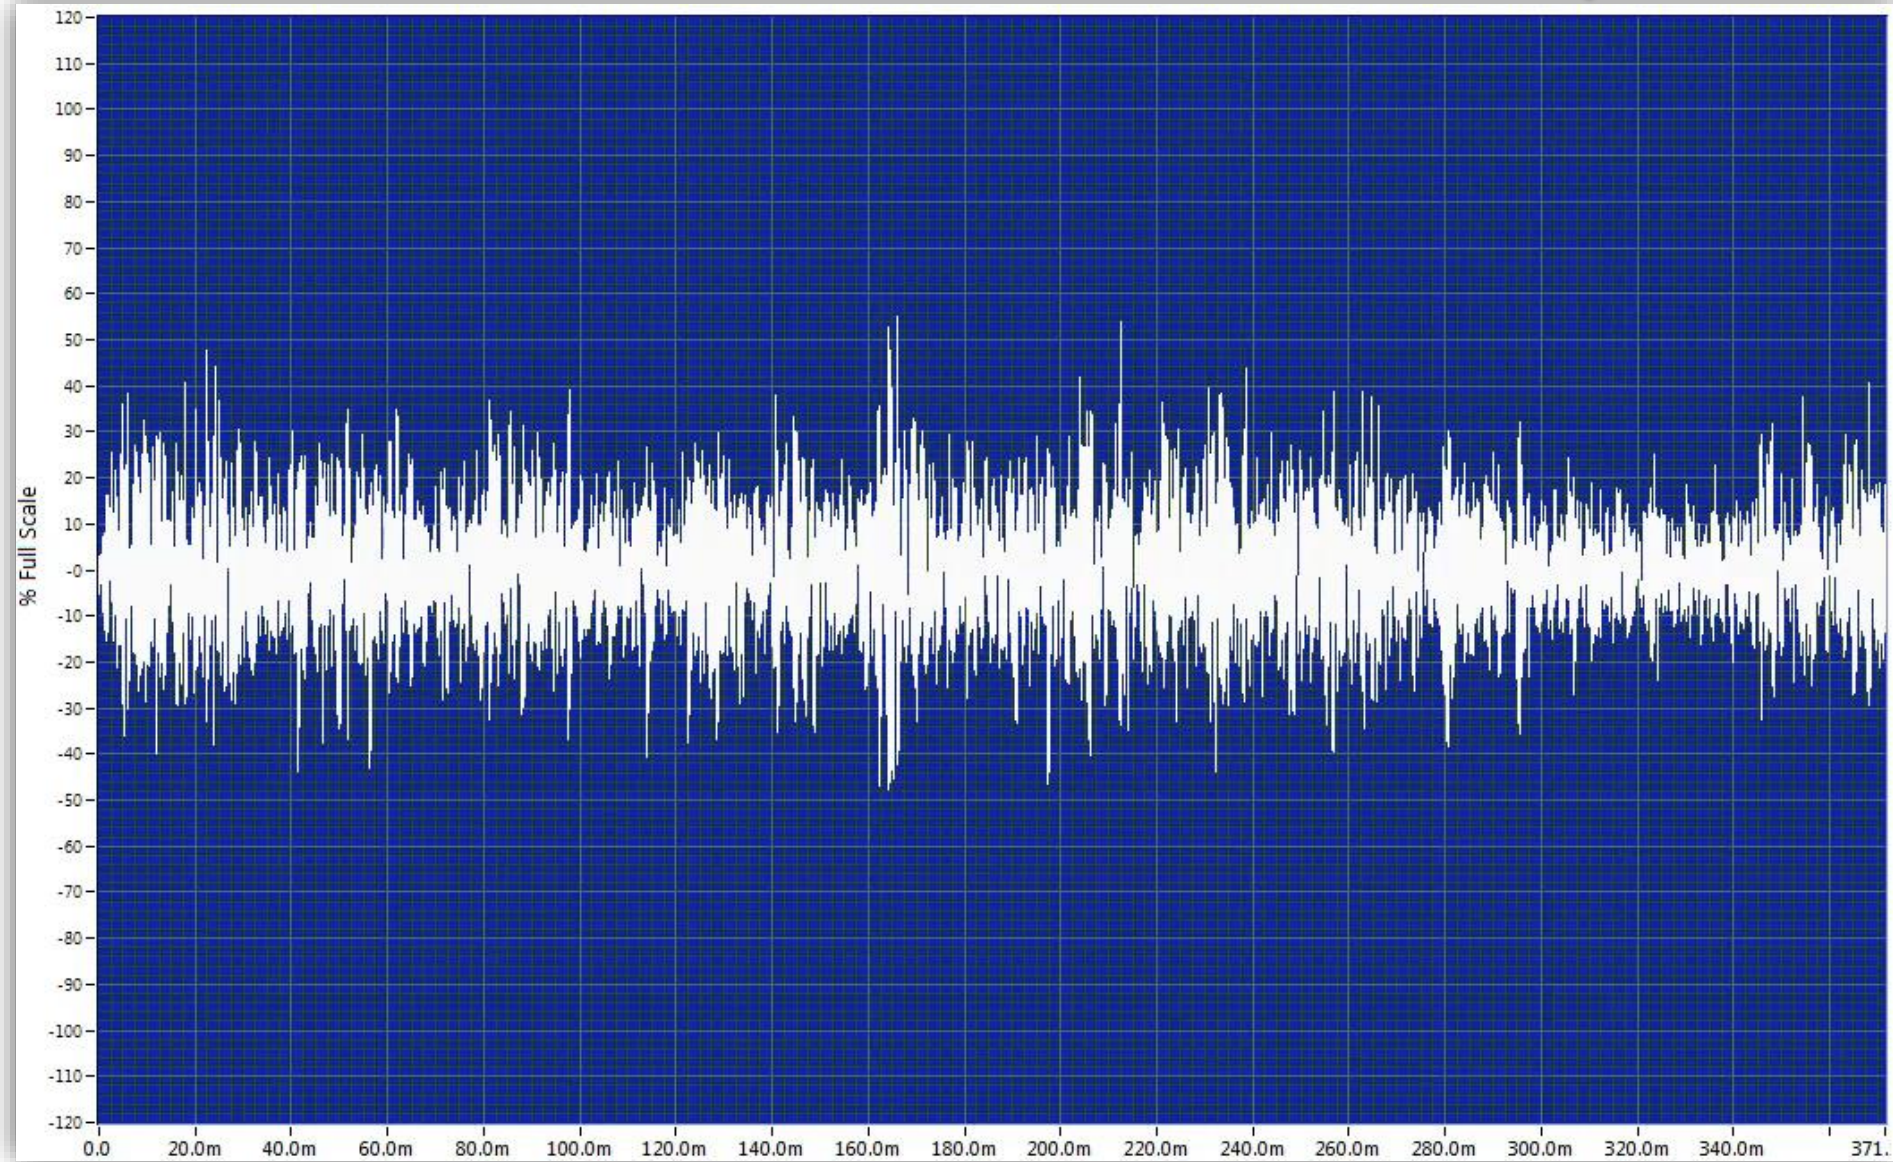
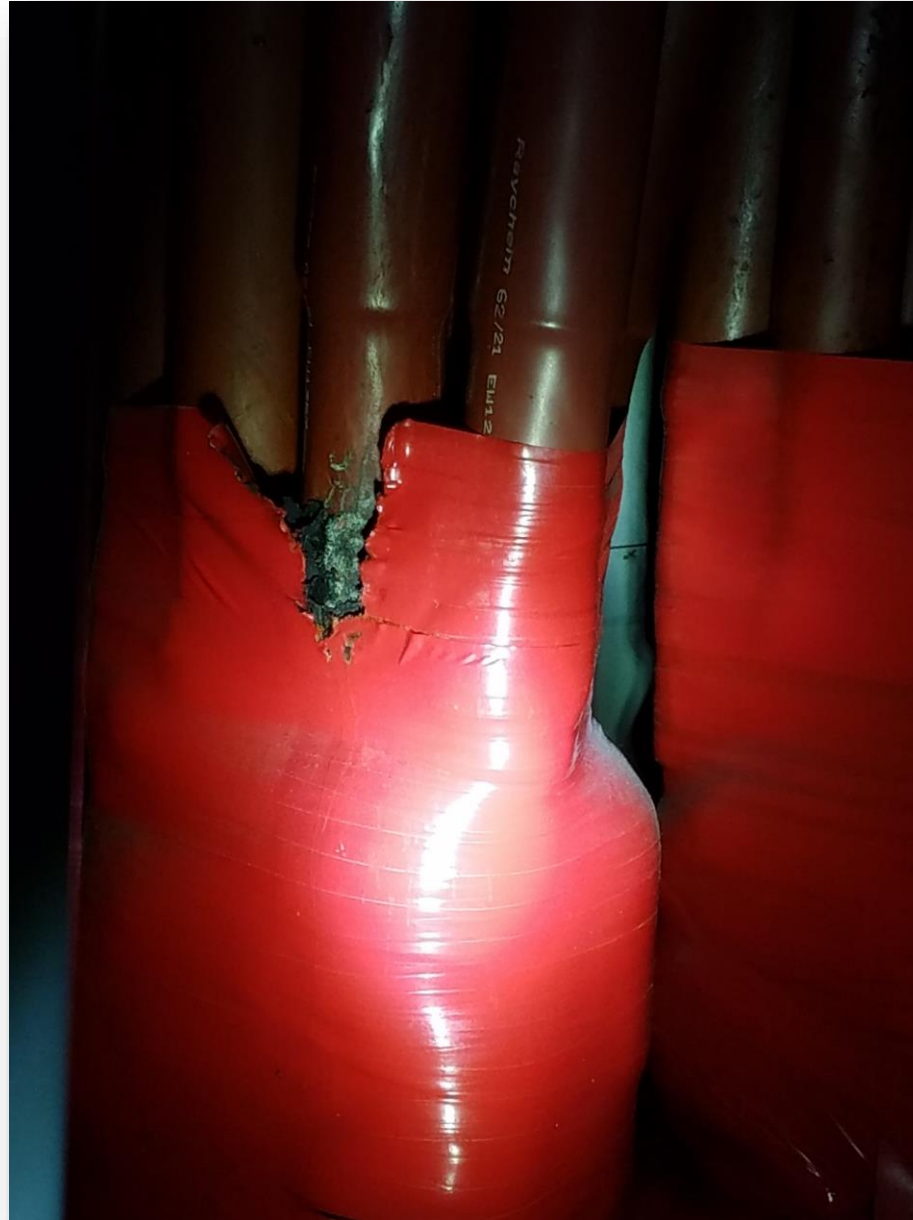
# Feeder Breaker

## Feeder Breaker – Arcing
